REPORT#: 2021-01 REPORT DATE: May 16, 2022

Sanitation Worker Struck by Backing Refuse Truck – North Carolina

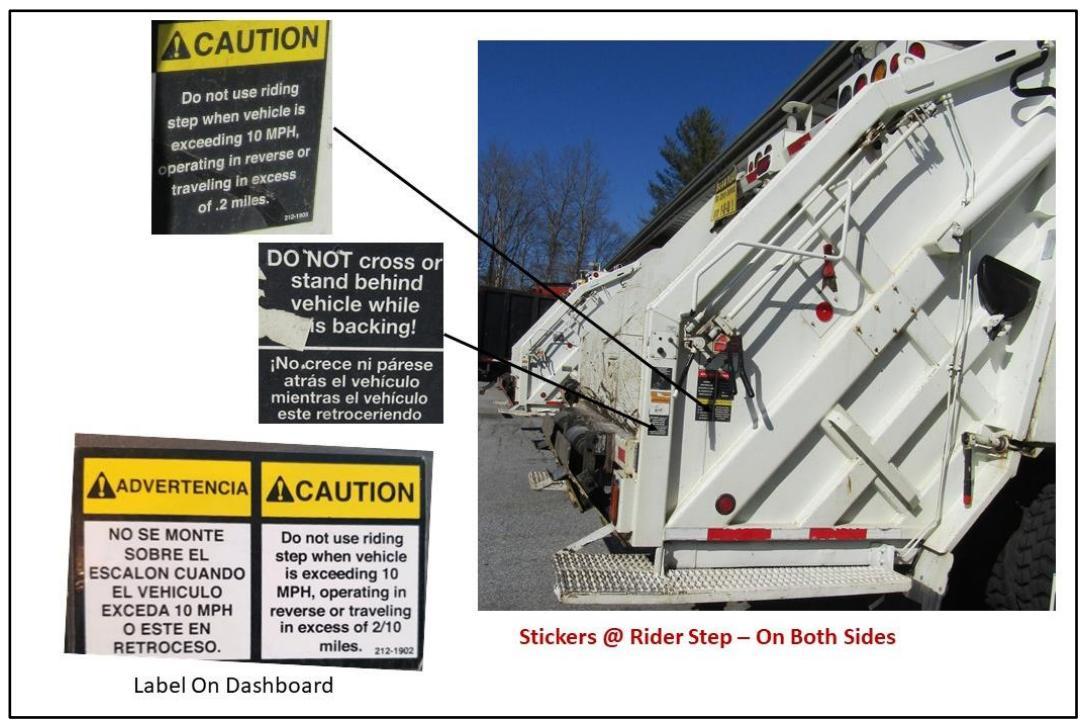
Photo 1. Passenger side rear label with locations on refuse truck. Photo courtesy of NC OSHA

Employees should be trained on safe driving and riding positions on refuse trucks when hired, yearly, as standards or equipment changes, and when an incident happens. Employers should ensure employees follow instructions on warning labels. The manufacturer stickers on the refuse truck instruct riders not to ride steps when in truck is operating in reverse, when traveling above 10 miles per hours, or when traveling continuously for 2/10 of a mile or more [Photo 1] [ANSI 2017].

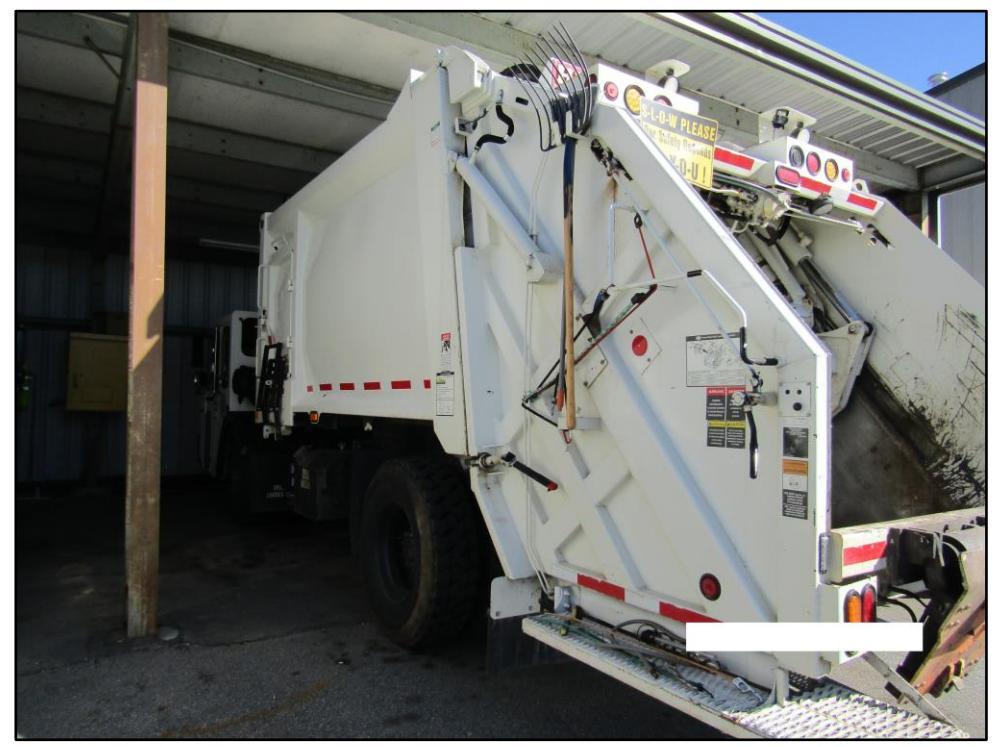
The residential refuse collections are Heil refuse collection units with Hines Specialty Vehicle bodies. The truck was a 2016 Crane Carrier model LETZ-30 truck chassis with a 2016 Heil model PT1000 refuse collection attachment [Photo 2]. Designed with rider steps on both the right back (passenger) and left back (driver) sides [Photo 3]. The refuse truck had manufacturer installed grab handles on the side above the rider steps [Photo 4]. The manufacturer stickers on the

Photo 2. 2016 Crane Carrier model LETZ-30 truck chassis with a 2016 Heil model PT1000 refuse collection attachment. Photo courtesy of NC OSHA

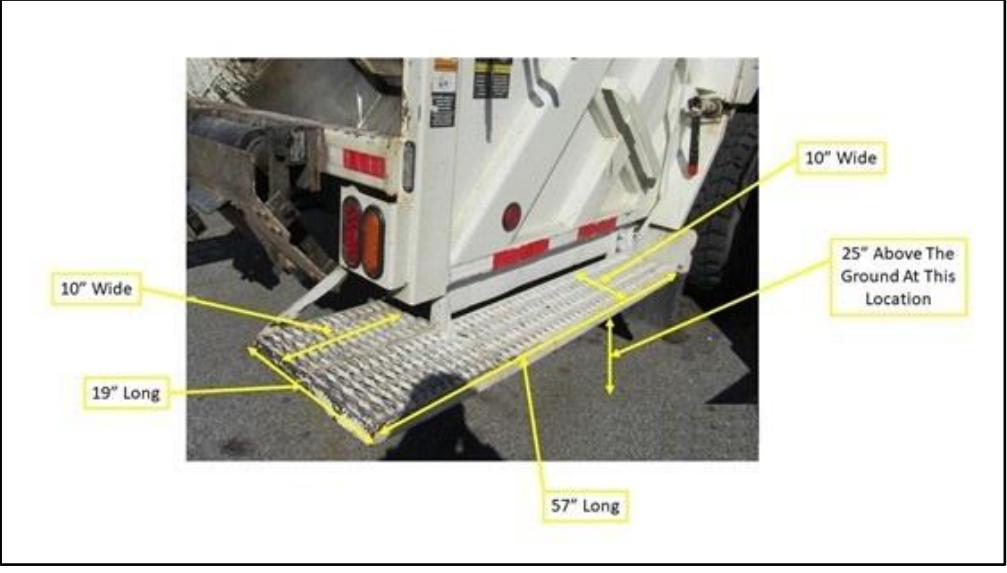
Photo 3. Rider step of refuse truck. Photo courtesy of NC OSHA

Discussion: Manufacturers of refuse equipment should design riding steps and passenger compartments that ensure rider and passenger safety during all times of routine vehicle operation. OSHA citations have recommendations for manufacturers' to "equip refuse collection vehicles with extended fenders or additional body panels to eliminate or reduce the likelihood of workers landing in the path of the vehicle's wheels in the event of a fall" [OSHA 2011; OSHA 2015]. The American National Standards Institute (ANSI) published Safety Standards for Mobile Refuse Collection and Compaction Equipment which includes recommendations for riding step design. ANSI Z245.1 9.9 provides the following requirements for riding steps design.

- Have a self-cleaning slip-resistant surface
- Be capable of supporting a vertical static load of 500 lbs. at the point furthest from its attachment point

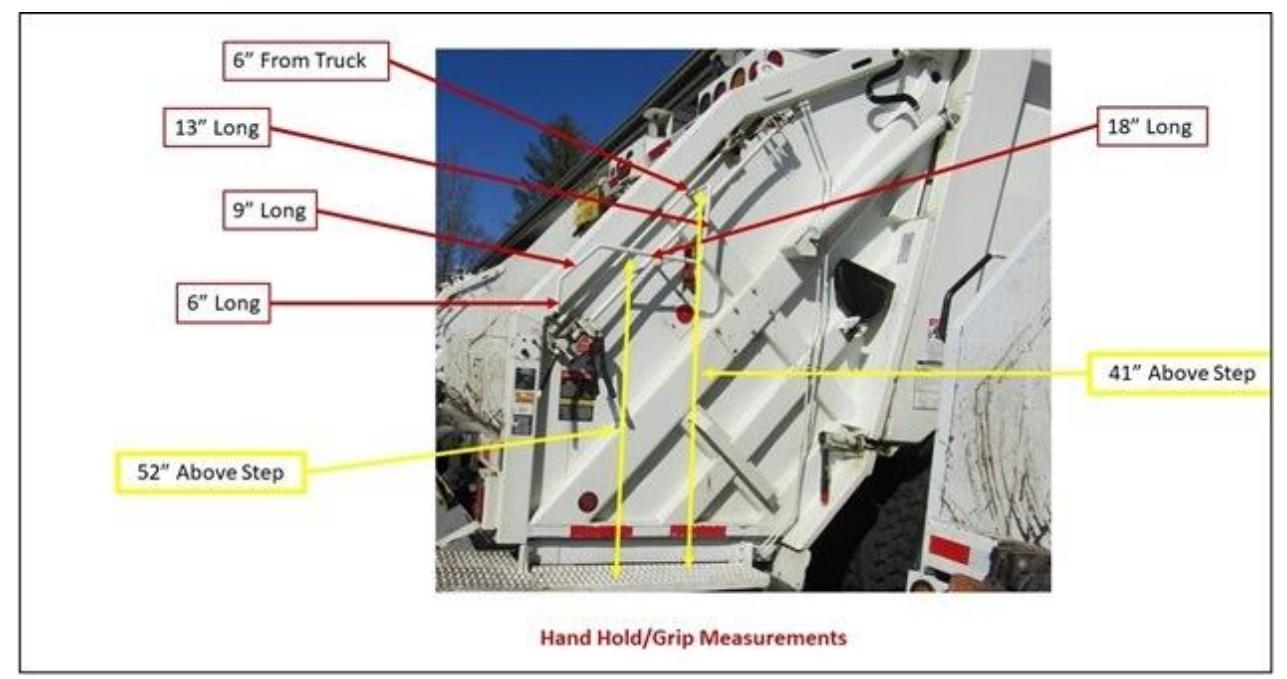
Photo 4. Hand holds of refuse truck. Photo courtesy of NC OSHA

- Be mounted not more than 24 inches above the road surface
- Have handhold(s), placed so that a rider who is positioned on the step, facing the side of the body, shall be able to attain four-point contact with the vehicle, using both hands and both feet at approximately shoulder width. Each handhold shall be capable of withstanding a horizontal static load of at least 500 lbs

- Handhold grip dimension shall not be less than 0.75 inches nor greater than 2 inches. Hand clearance shall not be less than 3 inches
- Have a depth of at least 8 inches and provide a minimum of 220 inches of surface area and

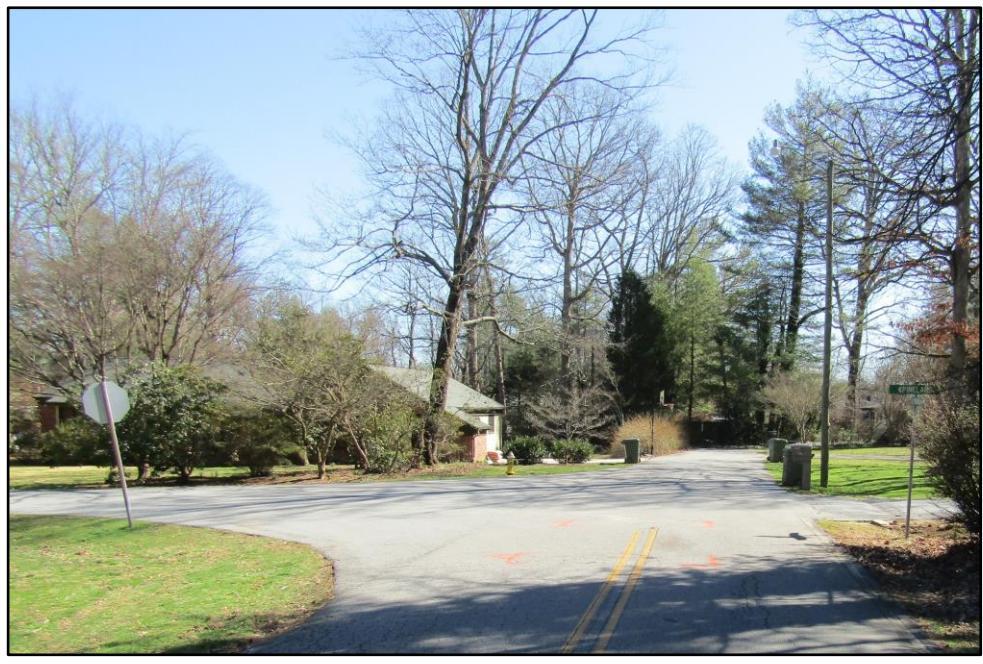
The incident occurred in a residential area at a "T" intersection of two streets. One of the arms of the T was a dead-end street [Photo 5]. There were three dead-end streets on this specific residential route which required backing. The crew was on the shortest of the three dead-end streets, which was approximately 125 feet. The other dead-end streets were approximately 500 feet and 300 feet. The housing development where the incident occurred was established in the 1970s. The streets were paved with a posted speed limit of 20 mph. There was no room for street parking, no cars parked on the street, and no sidewalks. The street was 20 feet wide, and the sanitation worker was struck 153 feet from the dead end of the street near the "T" intersection [Diagram].

Photo 5. Incident scene. Photo courtesy of NC OSHA

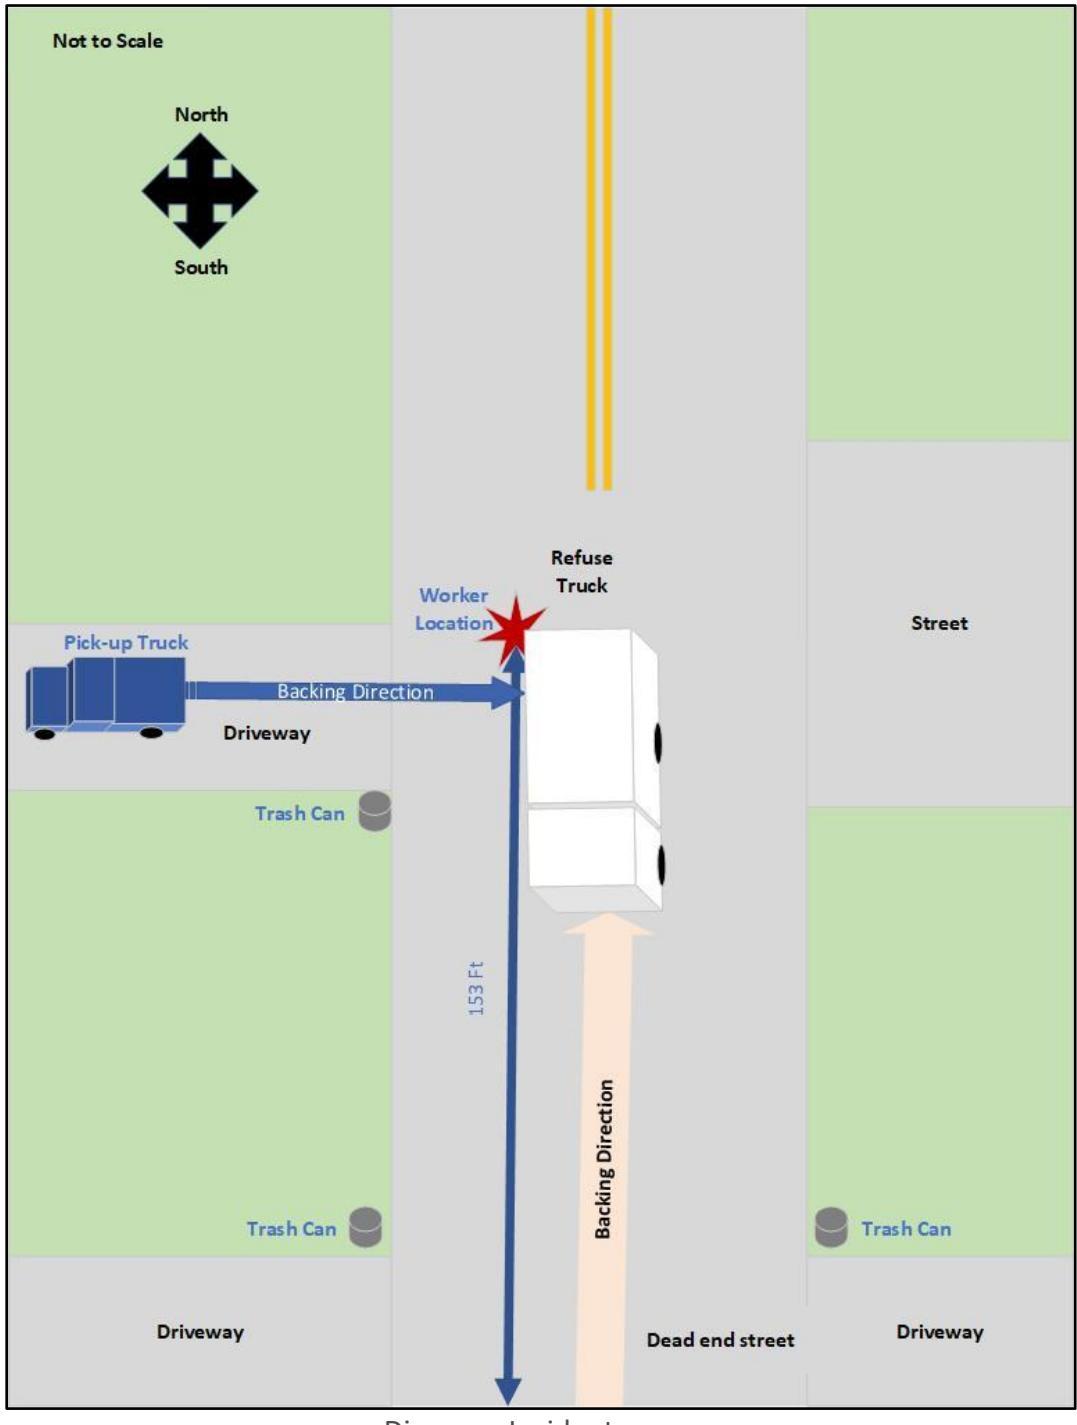
Diagram. Incident scene

With both sanitation workers riding on the back rider step following the stop at the "T" intersection [Diagram], the operator drove the refuse truck forward into the dead-end near the end of the pavement and stopped. One sanitation worker exited the right passenger side of the refuse truck to get the container on the right and the second sanitation worker exited on the left (driver's side of the truck) to get the container on the left. At approximately 8:40 am, after dumping the containers, the two sanitation workers got back on their rider steps, and the operator began backing the refuse truck out of the dead-end. At some point the sanitation worker on the right got off the step and was walking along the right passenger side of the refuse truck getting trash cans. As the refuse truck backed up, the sanitation worker on the right observed a pick-up truck from a residence backing out of the driveway on the driver's side of the truck at a rapid rate and thought it would hit the truck. The sanitation worker on the right yelled at the sanitation worker on the left and pointed to the backing vehicle. The sanitation worker on the left was startled by the backing pick-up truck and jumped from the rider step and landed on the road behind the moving refuse truck. The sanitation worker on the right hit the buzzer to notify the operator to stop. The refuse truck operator did not hear the buzzer notification and might have had the windows up with heat running. The refuse truck operator applied the brakes but was not able to stop the truck before it ran over the victim. The sanitation worker on the right reported the pick-up truck stopped on the road and only missed the refuse truck by about six inches. Following the incident, the operator placed a call to 911 then to the employer. Emergency response personnel were dispatched by 911 and pronounced the worker dead at the scene.
